50-year Flood Inundation Map and Digital Orthophoto of Santa Rosa de Aguán, Honduras

By
Peter G. Chirico, Michael B. Warner, and Emily C. Phillips

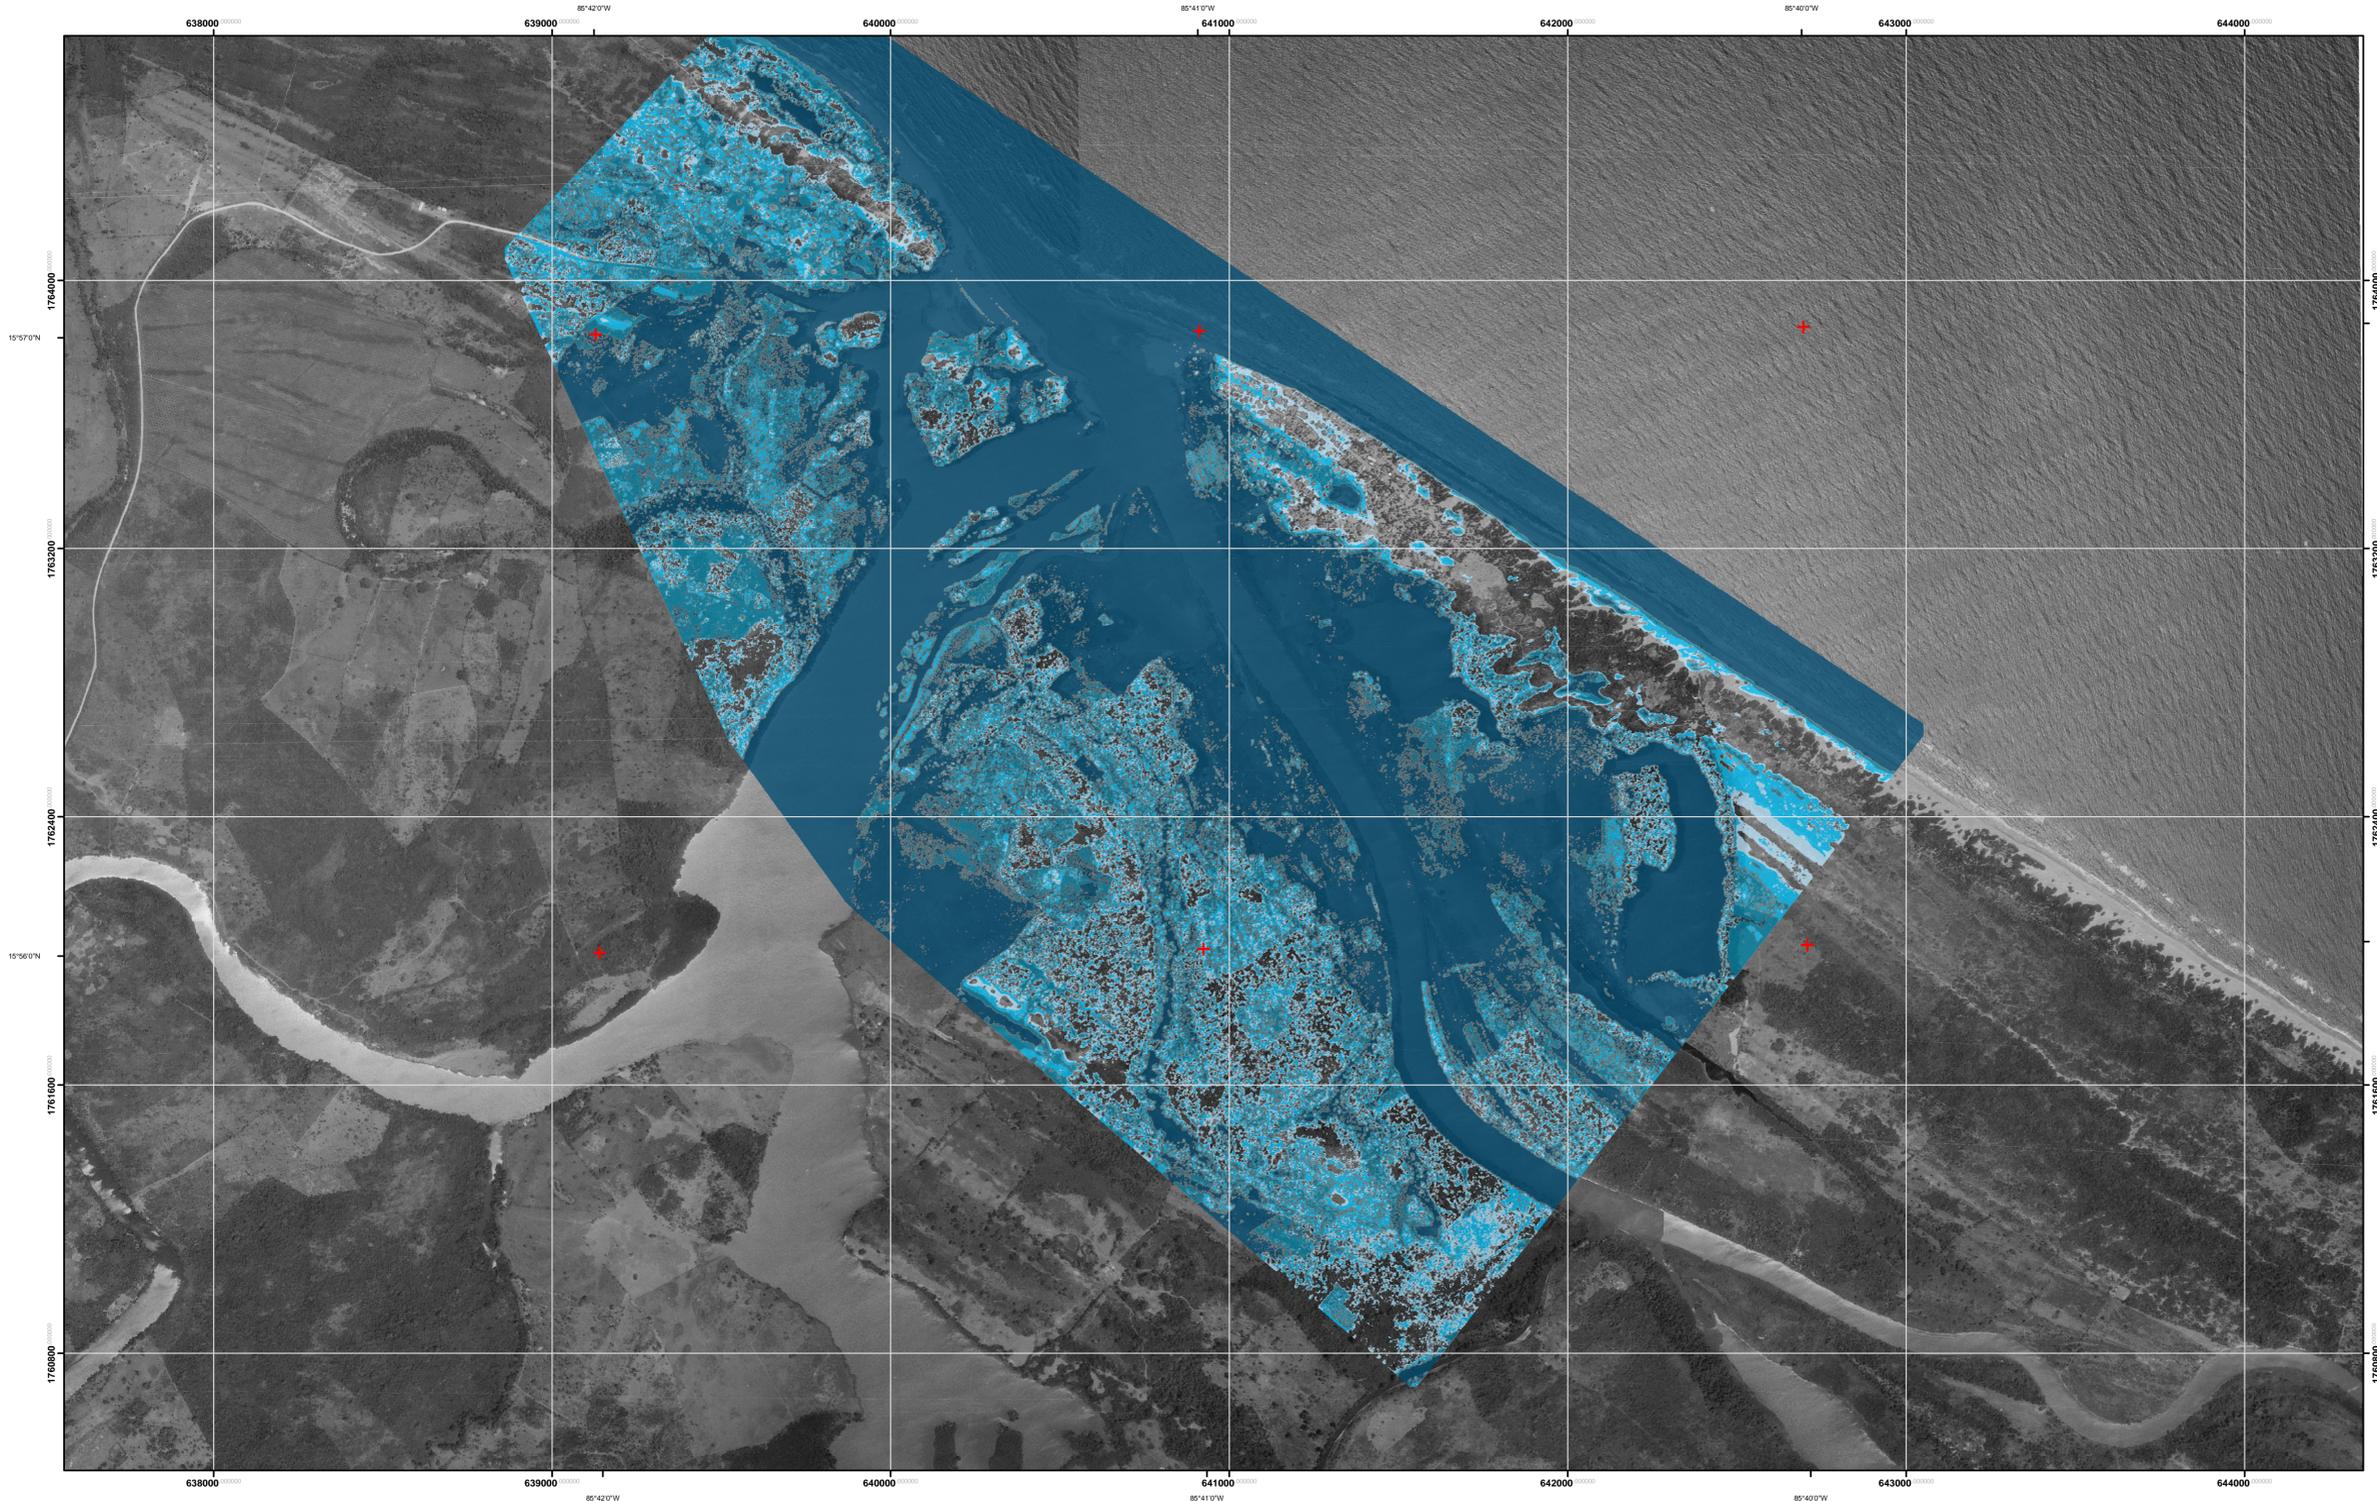
This map shows the calculated flood inundation polygons for the 50-year flood, for Santa Rosa de Aguán, Honduras overlain upon a USGS digital orthophoto derived from aerial photography. The data shown on this map were collected after Hurricane Mitch, which affected Central America in 1998, and were designed to assist municipal governments in hazard preparedness and planning.

Water-surface elevations for an estimated 50-year-flood discharge were determined using HEC-RAS, a one-dimensional step-backwater computer program. The channel and floodplain cross section geometry used in HEC-RAS were developed from an airborne light detection and ranging (LIDAR) topographic survey of the area. The 50-year-flood discharge was estimated using a regression equation that relates the 50-year-flood discharge to drainage area and mean annual precipitation. The area of inundation and depth of flood coverage was created with the HEC-RAS output and topographic TIN using HEC-geo-RAS software.

The 50-year flood depth maps provide a basis for land-use planning and for engineering design of structures near or within the floodplain of Santa Rosa de Aguán.

- Depth of Flood Inundation Approximately 0 to 1 Meter
- Calculated using HEC-RAS surface water model data collected in 2000 to model channel geometry.
- Depth of Flood Inundation Approximately 1 to 2 Meters
- Calculated using HEC-RAS surface water model data collected in 2000 to model channel geometry.
- Depth of Flood Inundation Approximately 2 to 3 Meters
- Calculated using HEC-RAS surface water model data collected in 2000 to model channel geometry.
- Depth of Flood Inundation over 3 Meters
- No Data Available

Orthophotos combine the image characteristics of a photograph with the geometric qualities of a map. This digital orthophoto has a 0.5-meter ground resolution. Original scanned aerial photography (scanned at 7 micron) was acquired from the USGS EROS Data Center. Ground control was acquired from field surveys performed by personnel and contractors from the USGS Mapping and Water Resources Divisions. Orthorectification was performed using ERDAS Imagine 8.5 Orthobase Pro. Digital elevation models used in orthorectification were prepared with ARC/INFO from digital vector layers following standard USGS DEM production procedures.

The contours were digitized from 1:50,000 scale topographic maps by the Instituto Geográfico Nacional of the Republic of Honduras. Data have not been altered to match the field checked orthophotos and may be less accurate than the orthophoto imagery.
